American BOA Success Story

The Challenge: Unable to Meet Quality Standards

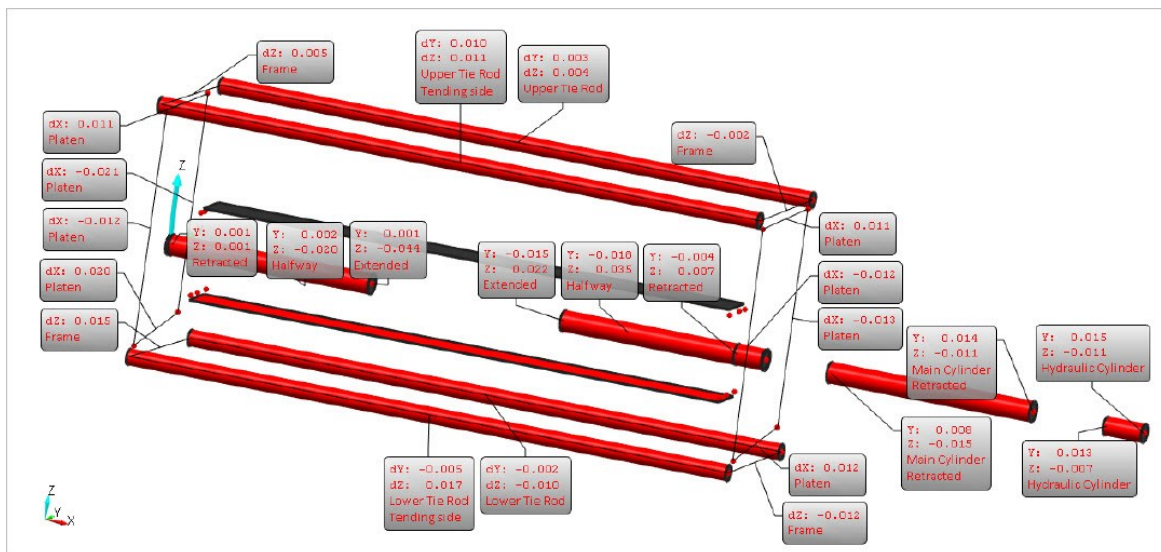
First, Guan visually inspected the machine for two things: how it functions, and where the inspections needed to occur. Additionally, he observed the process the machine goes through to actually make a part. He then determined what the most important components of the machine are, and where the most important inspections needed to be performed. "[Li] inspected every part that we had discussed", says Clifton, "and then built a model of the machine with the metrology software. The model showed both an out-of-level condition of the machine, as well as misalignment of its cylinders."

Image shows data captured by laser tracker and displayed in real-time using 3D software

"After all measurements were taken, he worked with us using the machine's adjustment bolts and we were able to take out nearly all of the misalignment," remarks Clifton. So much so, that the scope of the project could be expanded. What started as an alignment project on one machine turned out to be for three machines. Guan's quick success with the machines allowed for the scope of the project to expand beyond what was originally thought possible in this two-day project timeline. Clifton continues, "By the third machine we were ready to compare some parts. [Li] took some of the production parts, found our quality lab, and with our optical comparator he measured the angular and lateral offset of parts from four different machines in our facility, noting the results of each inspection. Then he went back out and worked with us to align yet ANOTHER machine (#3) and get its parts perfected."
