## Customer Success Story

### The Challenge: Damaged Embosser Unit

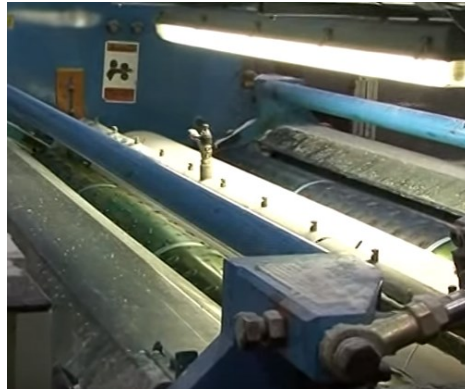
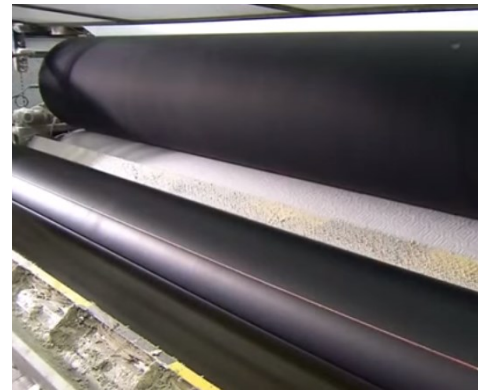
When a large tissue converter began experiencing severe wrinkling and baggy edges in one of their paper towel lines, they knew they had a serious problem, but were not sure where in the line the issue was occurring.

Because the product was tracking tight to one side and bagging severely on the other when running from the embosser to the winder, the mill team believed that the embosser unit was the problem. They were so convinced this unit was causing the issue that they were planning to purchase and install a new embosser.

During the inspection, Mr. Fox found that the major fixed components were all well within an acceptable tolerance. However, he found that there was significant misalignment in many of the idler rolls. In fact, one roll was out 5/8" because of a severely bent mounting bracket. This particular roll is of great importance to the process due to the amount of wrap and the length of draw between the two components. Ultimately, this misalignment was creating the baggy edge as the product was going into the winder. When Mr. Fox met with the mill team to discuss his inspection data, it was decided that OASIS would come back to align all idler rolls.

Again using a laser tracker, Mr. Fox and OASIS field service engineers, Mike Shirley and Ken Endean, made the adjustments by aligning all idler rolls within an acceptable tolerance. Additionally, they worked with the mill machinist in order to modify the bent bracket of the severely misaligned roll so that the roll could be properly aligned.

Since the roll alignment, this mill has seen a major improvement in this line. The wrinkles and baggy edges have been eliminated and the mill has been able to increase machine speed. The most impressive result of the alignment project however, is that **the mill was able to avoid purchasing and installing a new embosser**. A significant cost savings to be sure.
