Overlooking Rockers and Rocker Plates Can Lead to Dryer Component Failures

Presented by Myron Smith, OASIS Alignment Services

PaperCon 2016

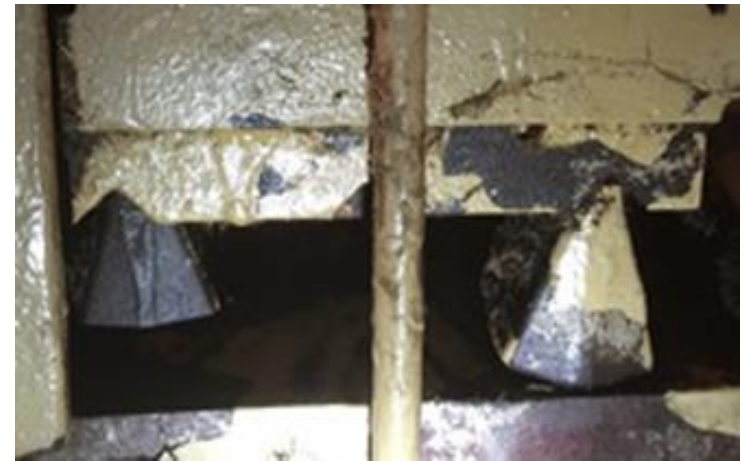
- Missing rockers
 - Rockers misplaced after bearing repairs
 - Extremely high felt PLI (pressure per lineal inch)
 - Lower dryers can lift
 - Rockers fall over
 - Rockers fall out of place if cover/inspection plates are removed and not reinstalled

**Rockers not properly positioned*

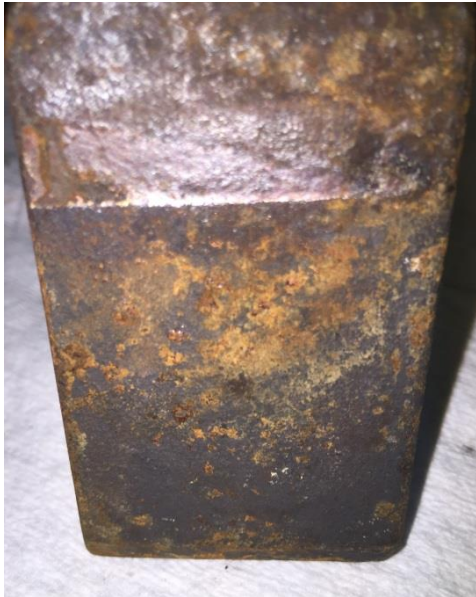
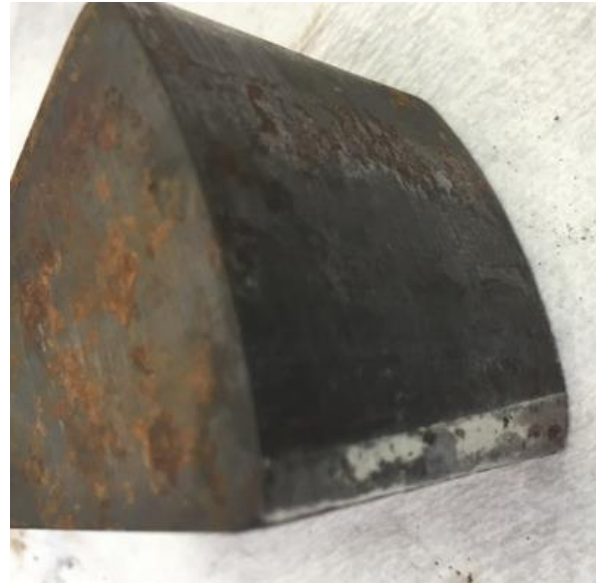
Do not run with worn or damaged rockers!

Images show same rocker with worn top right and bottom left. Machine was running with rocker in wrong position. Over time, this will cause much more extensive problems than rocker wear!

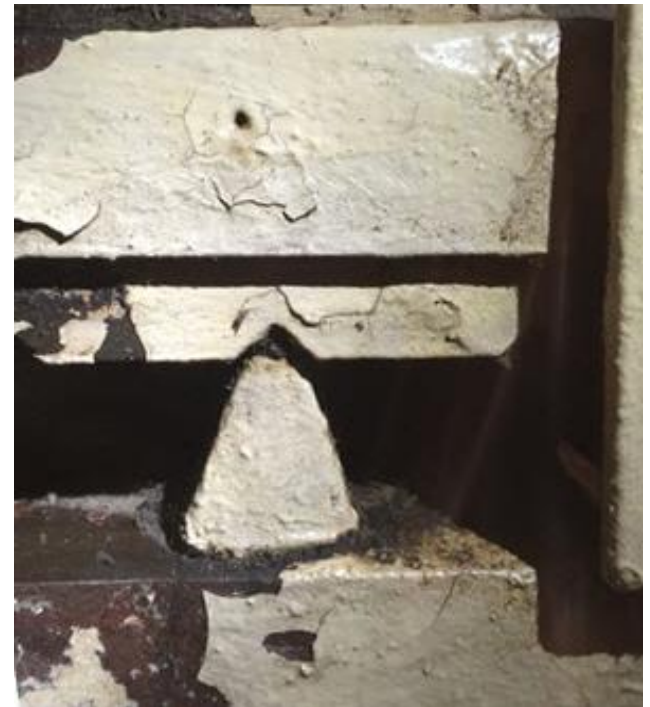
- Remove inspection plates (if they exist), inspect for:
 - Missing rockers
 - Rocker position
 - Rocker wear
 - Broken worn or damaged plates
 - Damaged bearing housings

**Rocker in proper position*
