Precision Alignment of Winders

Winder speeds must increase to keep pace with higher operating speeds of paper machines. At high speeds, any misalignment of the winder can have a detrimental effect on operation and production rates.

MYRON SMITH and ROGER CROSS

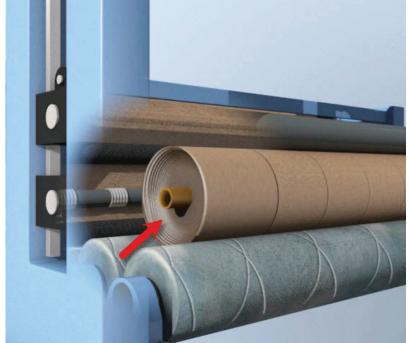
Figure 2. Dishing. Source: OASIS Alignment Services, Inc.

- Dishing, shown in Figure 2, can occur when rider roll, winder drum, or core chuck misalignment causes the product to move incrementally in the axial direction. This continuous movement creates dish-shaped ends on the roll.
- Interweaving, shown in Figure 3, is the result of misalignment in the rolls following the slitters. Here, two adjacent strips of the slit web overlap during winding so that the adjacent rolls intertwine. This often can't be separated and such rolls must be scrapped.
- Offsets, shown in Figure 4, are "steps" in the edge of the roll formed by rider roll misalignment that produces non uniform nip loads. They can also be caused by tension variations in the web, causing the web to shift due to the guiding action of the misaligned rolls.
